**HOME
INSPECTIONS**

Property Inspection Report

12345 Somewhere Ave, ACity, CO 12345
Inspection prepared for: Smith John
Date of Inspection: 7/19/2019 Time: 10:30
Age of Home: 2016 Size: 2939
Weather: 95 hot
SAMPLE REPORT

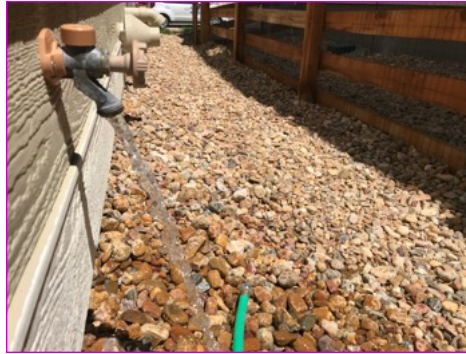
EXTERIOR PLUMBING Exterior Faucets

- At the time of the inspection, the Inspector observed no deficiencies in the condition of exterior water faucets.

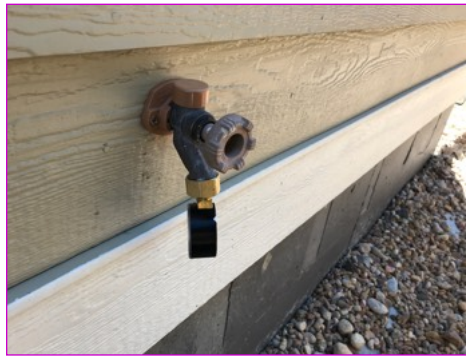
EXTERIOR PLUMBING Water Pressure

- Appeared to be around 80psi

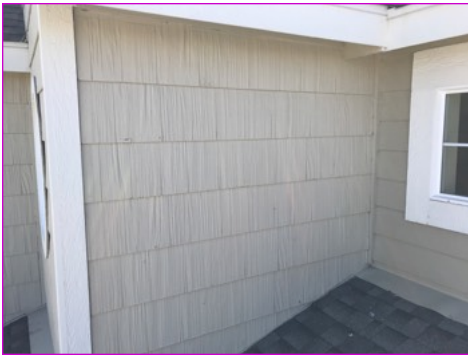
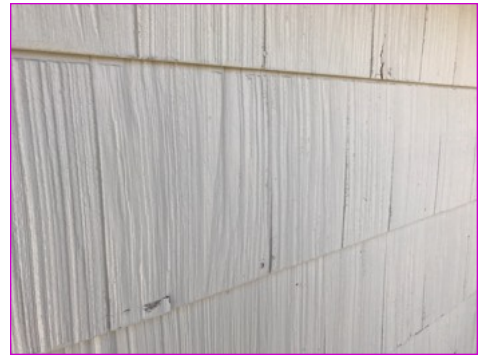
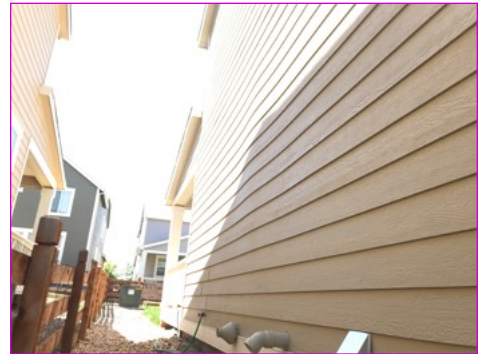
- At the time of the inspection, the composite siding covering exterior walls exhibited general moderate deterioration commensurate with the age of the home. Some areas of the siding and trim will need to be painted (touch-up) and caulked (trim) to prevent moisture intrusion.

- Buckling visible in areas of the composite siding covering exterior walls (left side of the home) appeared to be the result of the lack of expansion gaps where the ends of siding boards met (butt joints). The manufacturer recommends that 3/16-inch gaps be left at butt joints to allow for siding expansion with changes in temperature. Confirmation would require removal of joint flashing which lies beyond the scope of a home inspection.

- Some areas of the siding and trim (minor) will need to be painted (touch-up) and caulked (trim) to prevent moisture intrusion.

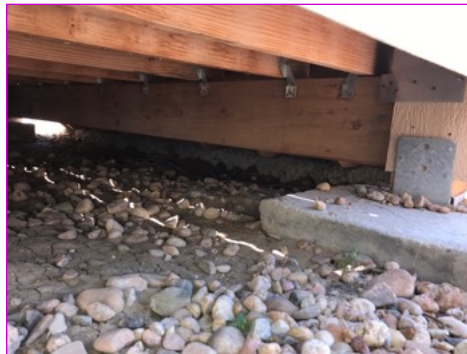
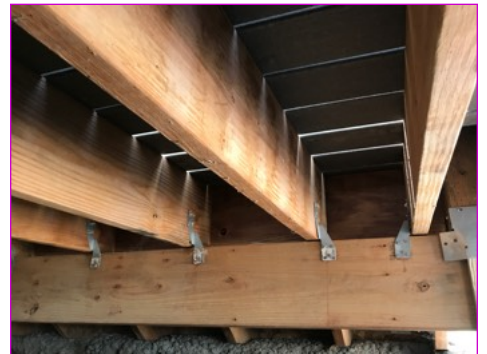
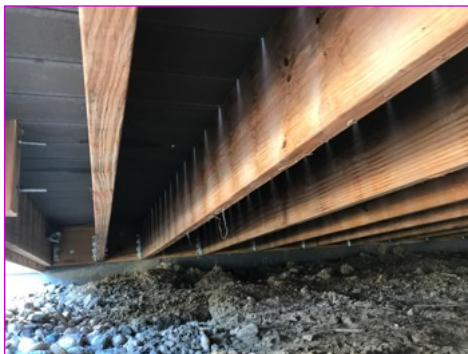
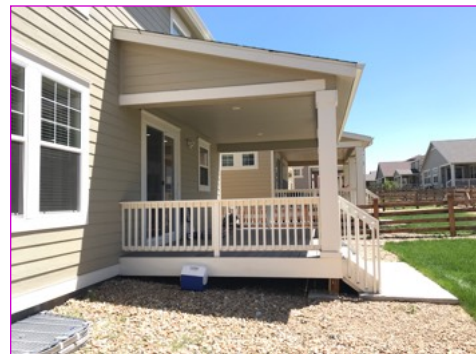
- At the time of the inspection, the Inspector observed no deficiencies in the condition of this deck.

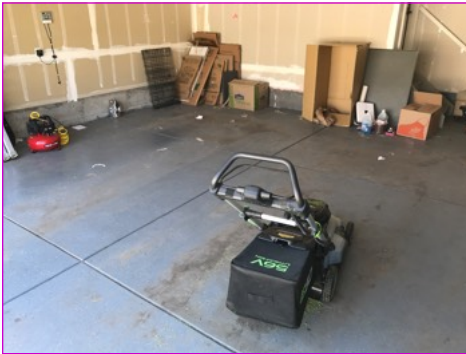
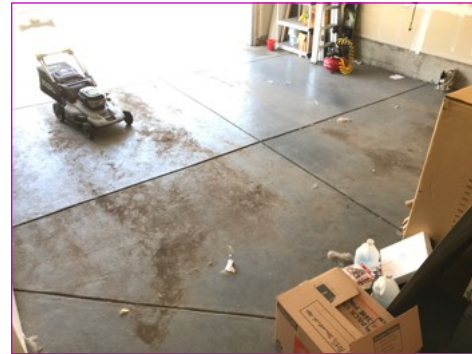
GARAGE Garage Floor

- At the time of the inspection, the Inspector observed no deficiencies in the condition of the garage floor.

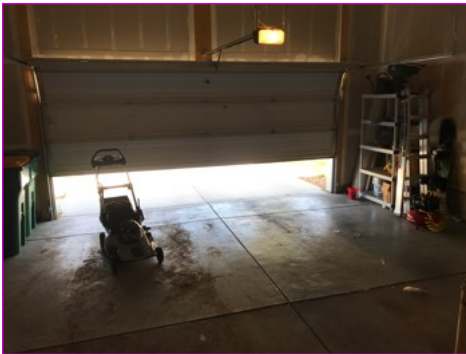
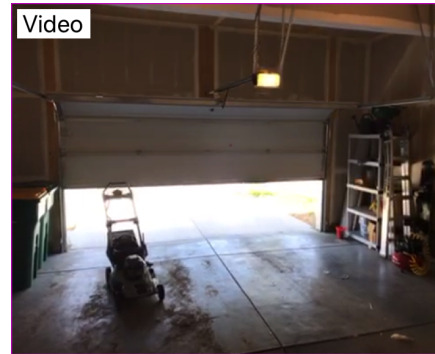
- At the time of the inspection, the Inspector observed no deficiencies in the condition of the overhead vehicle doors.

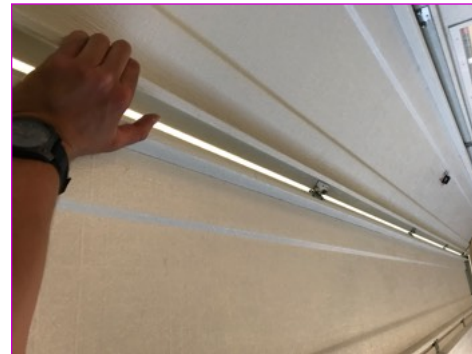
- The pressure-activated automatic reverse feature was tested and appeared to be operating in a satisfactory manner at the time of the inspection. Garage doors are not tested by the Inspector using specialized equipment and this inspection will not confirm adherence to manufacturer's specifications. This inspection is performed according to the Inspector's judgment from past experience. You should adjust your expectations accordingly. If you wish to ensure that the garage door complies with the manufacturer's specifications you should have the it inspected by a qualified contractor or technician.

- The photoelectric sensor designed to activate the automatic-reverse at the overhead garage door responded to testing as designed.

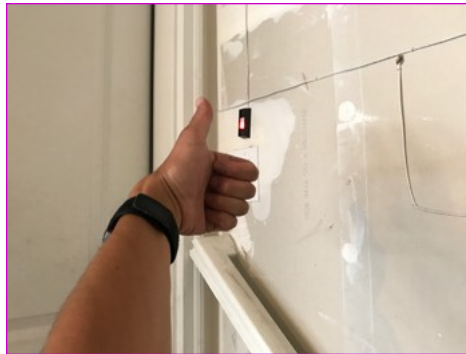
OVERHEAD GARAGE DOOR Automatic Opener Switch

- The push-button switch for the automatic garage door opener was operable and safely located at the time of the inspection.

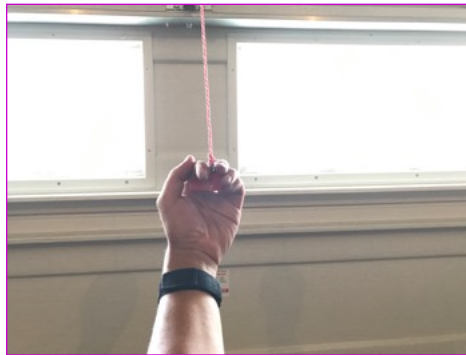
OVERHEAD GARAGE DOOR Manual Disconnect

- At the time of the inspection, the Inspector observed no deficiencies in the operation of the manual disconnect.

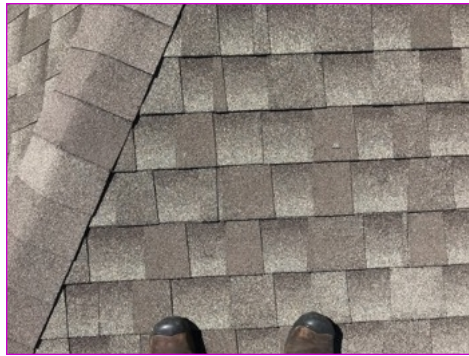
- The roof was covered with laminated fiberglass asphalt shingles, also called "architectural" or "dimensional" shingles. Laminated shingles are composed of multiple layers bonded together. Fiberglass shingles are composed of a fiberglass mat embedded in asphalt and covered with ceramic-coated mineral granules. Shingles with multiple layers bonded together are usually more durable than shingles composed of a single layer.

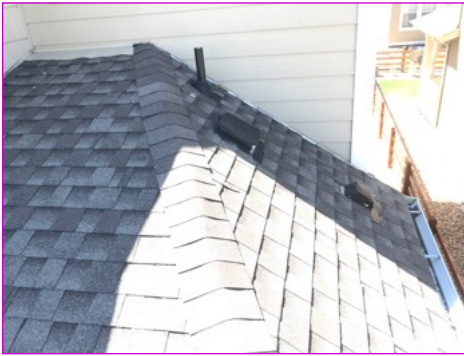
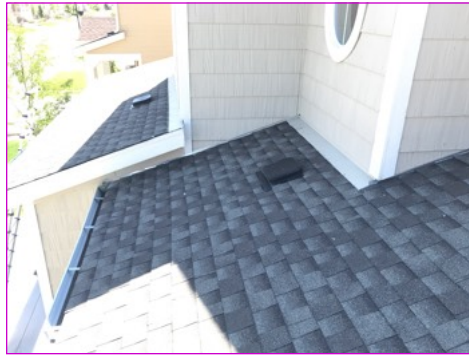
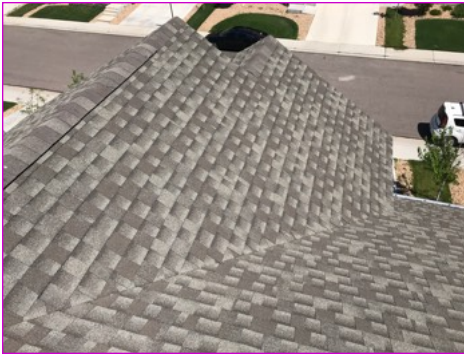
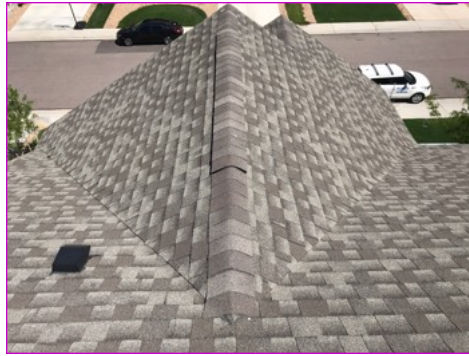
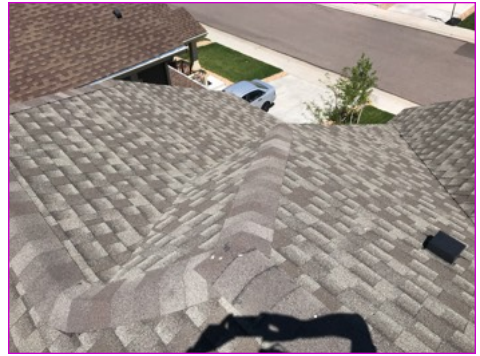
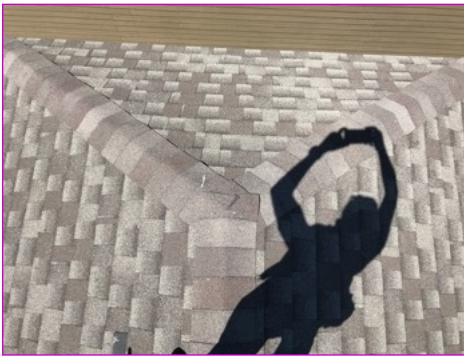
- The Inspector observed few deficiencies in the condition of the composition asphalt shingle roof-covering material. Notable exceptions will be listed in this report.

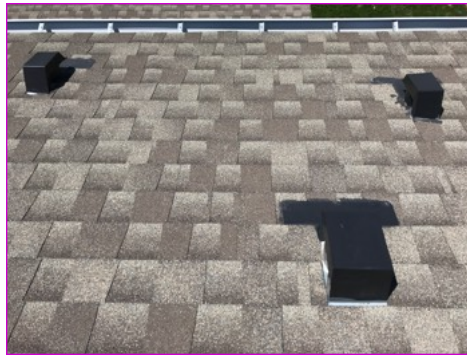
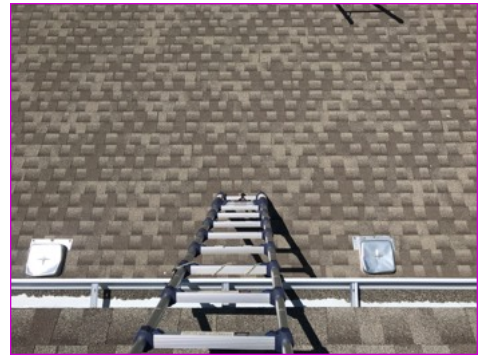
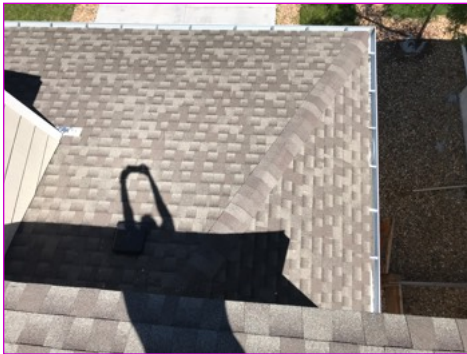
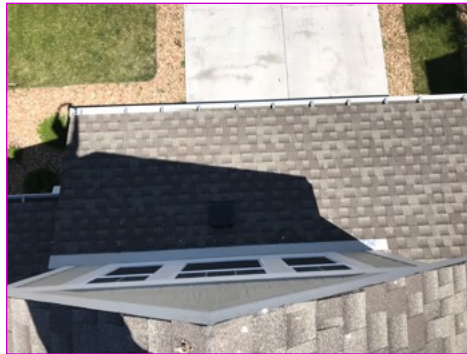
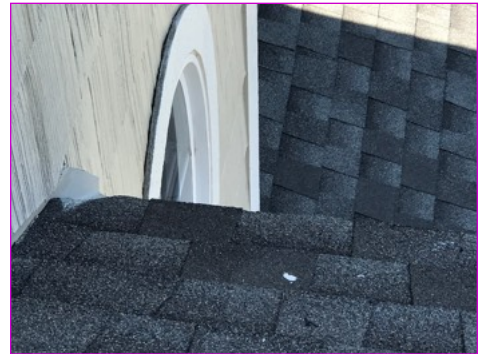
3. Hail Damage

- At the time of the inspection, the asphalt composition shingle roof had very minor damage visible that appeared to be the result of hail strikes and was localized, not widespread. This damage appeared to be cosmetic only. Right side of the roof.
- The grey color of asphalt exposed by hail strikes indicated that this damage is old.

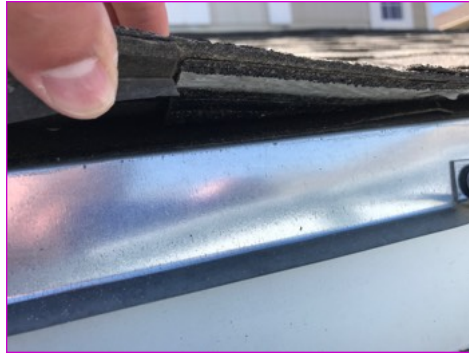
1 Layer

- The roof had one layer of asphalt shingles installed at the time of the inspection.

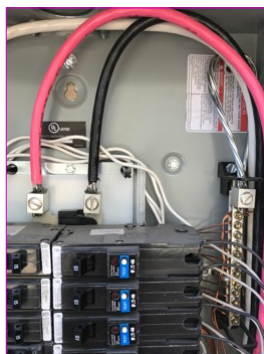
SUB-PANEL Feeder Conductor Condition

- Markings describing the amperage rating of the sub-panel feeder conductors were not visible on the conductor insulation and the Inspector was unable to confirm proper rating. Confirmation of correct main conductor rating would require the services of a qualified electrical contractor.

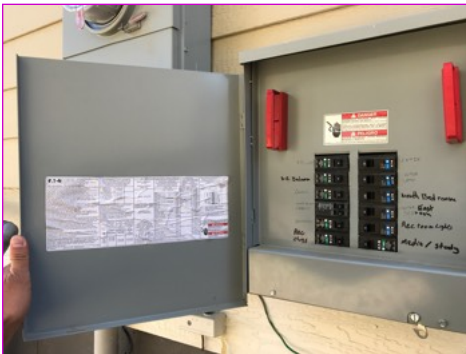
- The manufacturer's label is shown in the photo.

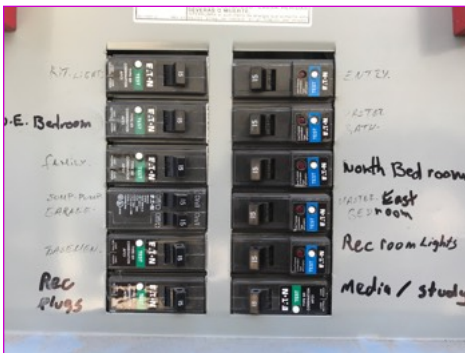
- The manufacturer's label listed the amperage rating of this sub-panel at 125 amps.

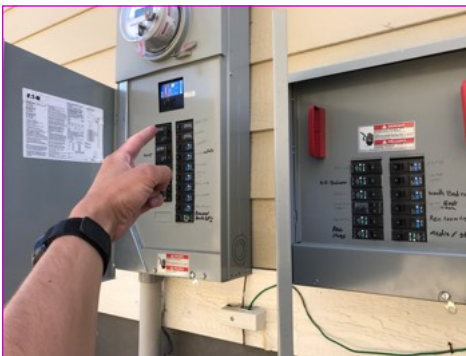
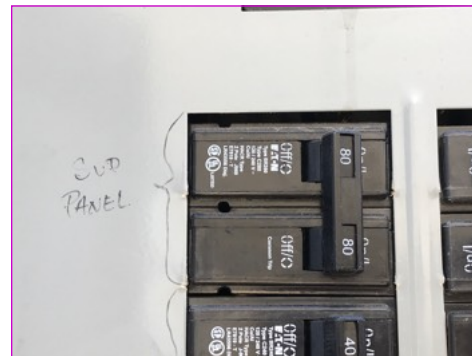
SUB-PANEL Panel Disconnect

- The main disconnect for this sub-panel was a breaker type.

80 AMPs at sub panel

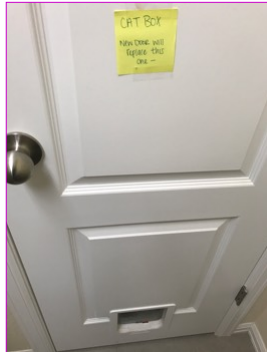
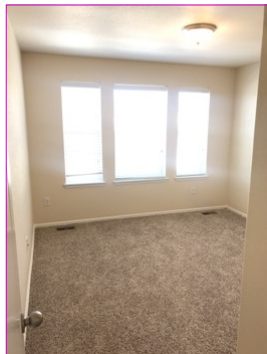
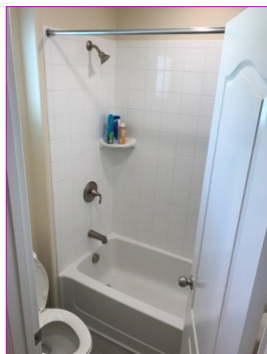
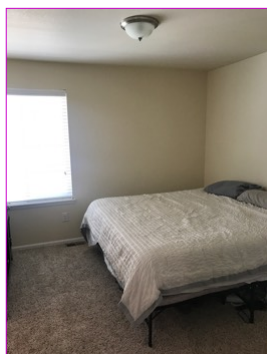
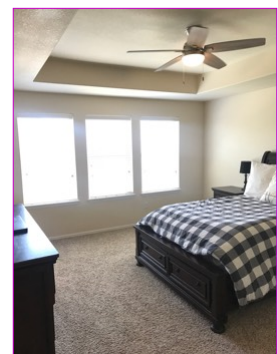
1. General Condition

- The home had a strong odor at the time of the inspection that appeared to be connected with animal excrement. Laundry closet, upstairs and master closet smelled the worst.

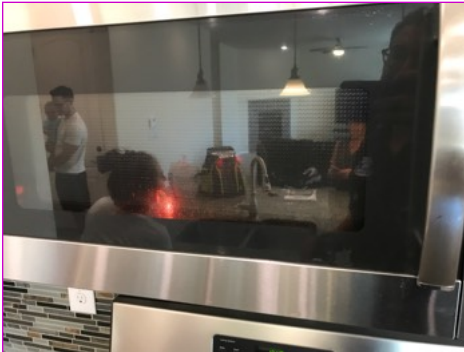
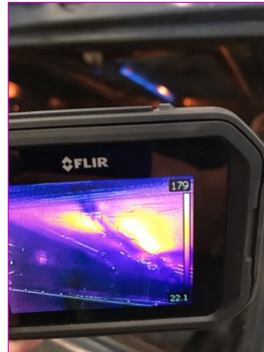
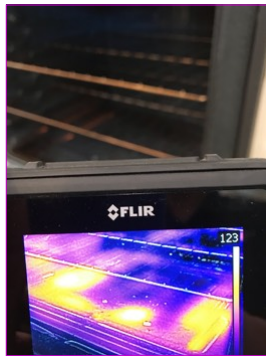
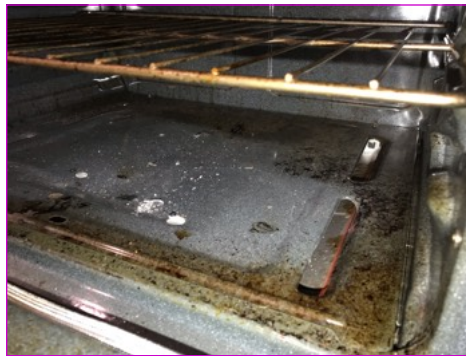
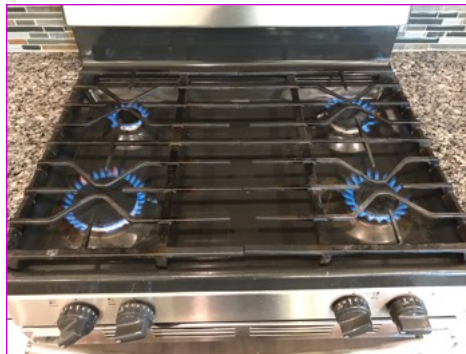
1. General Condition

- At the time of the inspection, the Inspector observed no deficiencies in the condition of the kitchen.

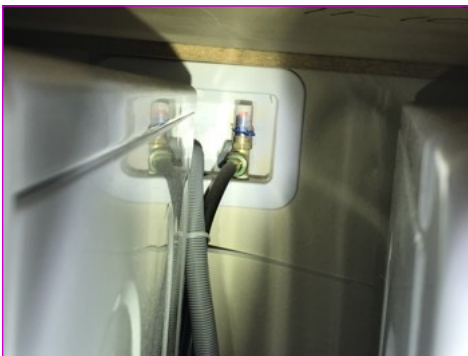
- At the time of the inspection, the Inspector observed no deficiencies in the condition of the laundry room.

The inspector suggests replacing the rubber hoses at the washer with flexible metal hose for increased reliability.

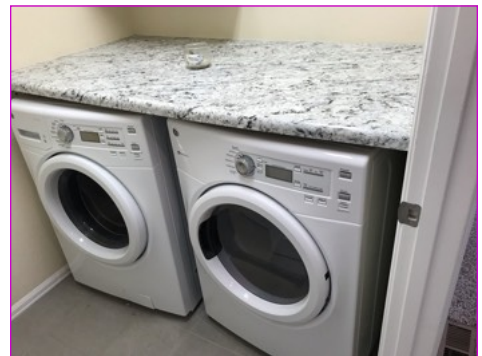
Limited view due to counter top in laundry.

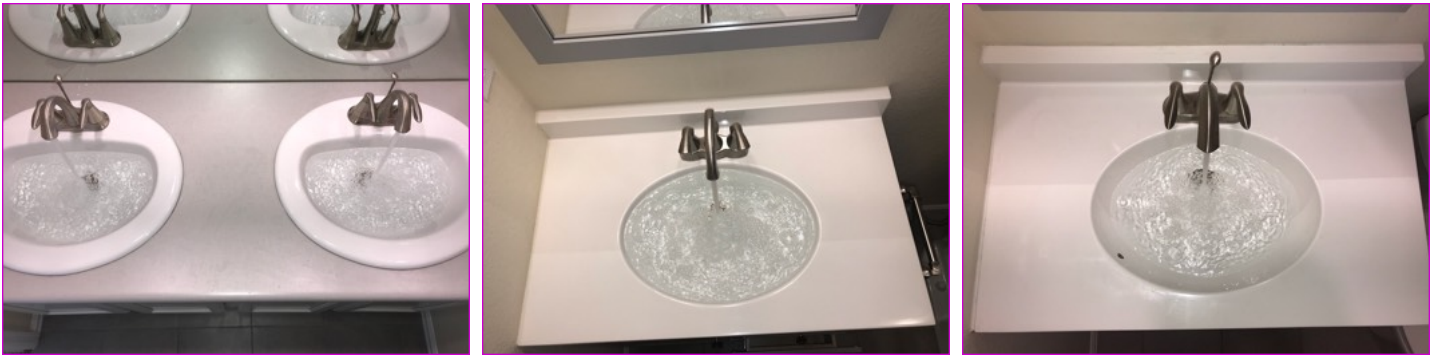
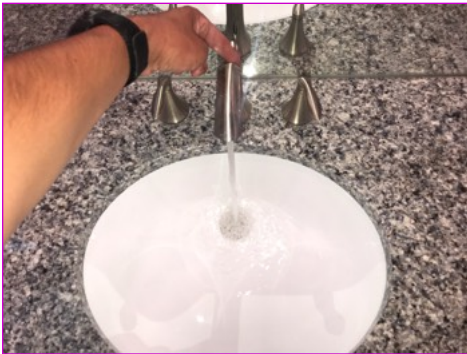
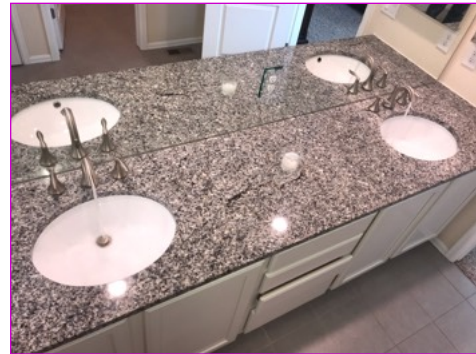
stopper mechanism needs to be adjusted

*Stopper mechanism in master
bath was not connected.
Reconnect or replace.*

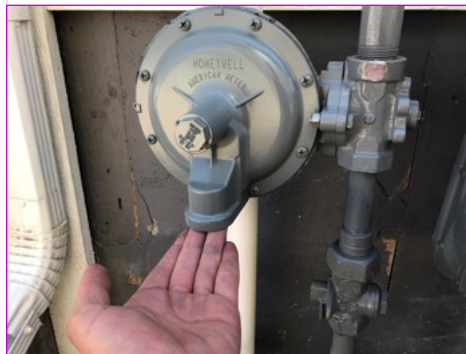
GAS SYSTEM Gas Regulator

- The photo shows the gas pressure regulator that controls the pressure under which gas is supplied to the home. Gas regulators leak small amounts of gas occasionally. If gas smell is strong and persists, contact your local gas utility provider.

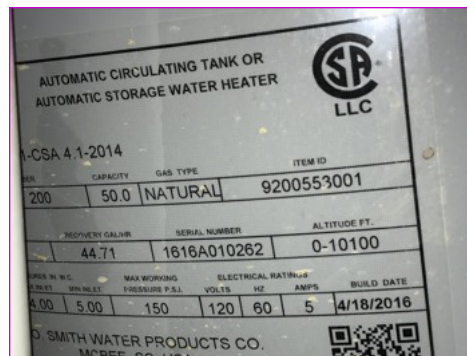
- 2016 manufacturing date

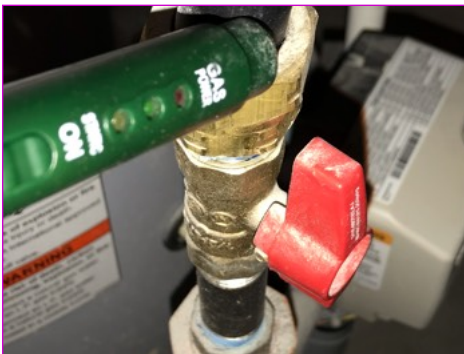
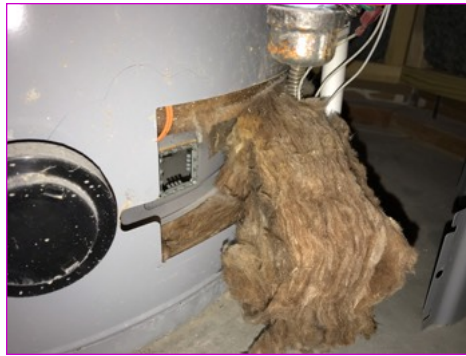
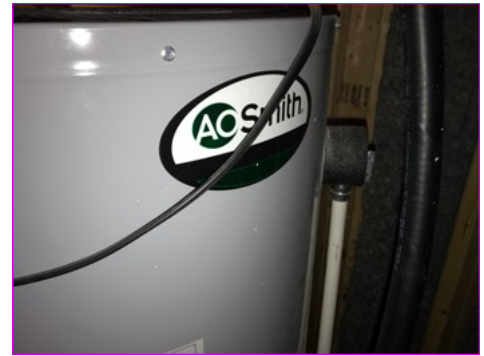
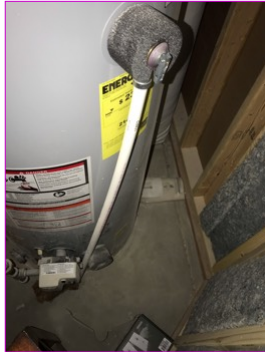
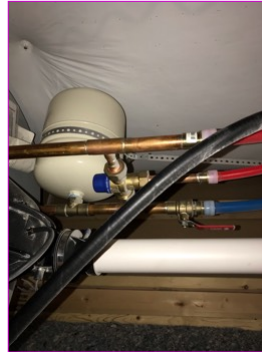
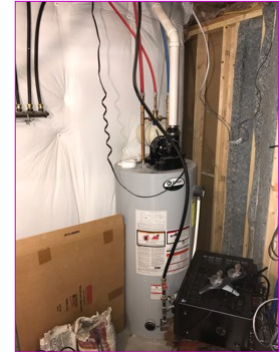
4. General Condition

- At the time of the inspection, the Inspector observed no deficiencies in the condition or operation of the water heater.

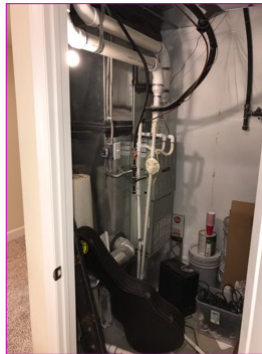
FURNACE Furnace Location

- The furnace was located in the basement.

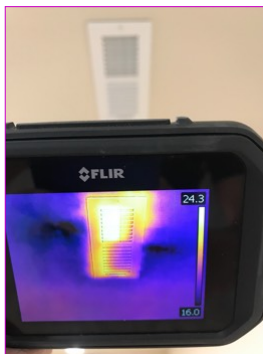
FURNACE Furnace Operation

- This furnace responded adequately to the call for heat.

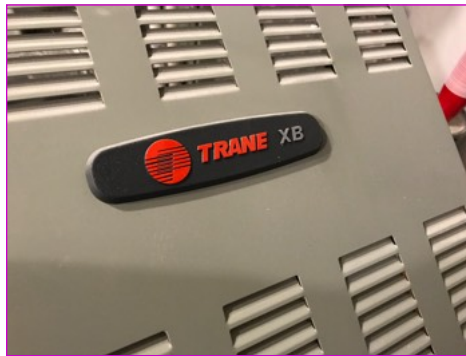
FURNACE Furnace Manufacturer

2016 manufacturing date

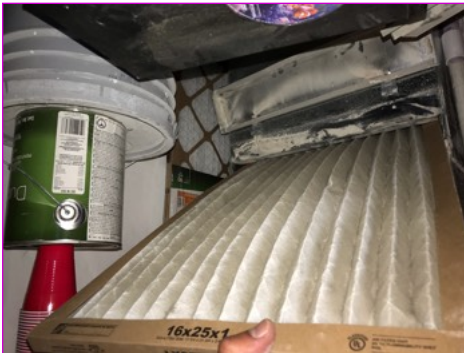
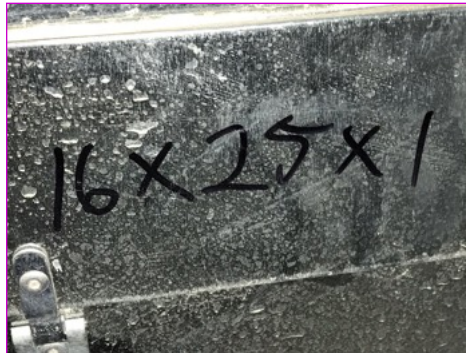
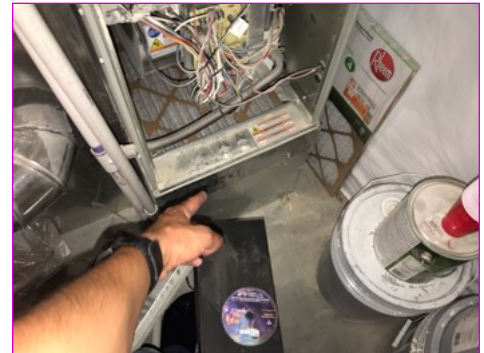
FURNACE Furnace Air Filter

- The air filter for this furnace was dirty and should be changed. Filters should be checked every three months and replaced when they reach a condition in which accumulation of particles becomes so thick that particles may be blown loose from the filter and into indoor air. Homes in areas with high indoor levels of airborne pollen or dust may need to have air filters checked and changed more frequently.
- Failure to change the filter when needed may result in the following problems:
 - Reduced blower life due to dirt build-up on vanes, which increasing operating costs.
 - Reduced indoor air quality.
 - Increased resistance resulting in the filter being sucked into the blower. This condition can be a potential fire hazard.
 - Frost build-up on air-conditioner evaporator coils, resulting in reduced cooling efficiency and possible damage.
 - Reduced air flow through the home.

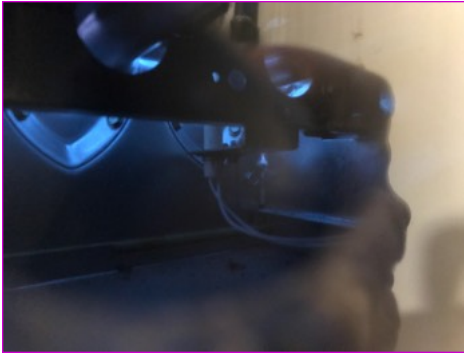
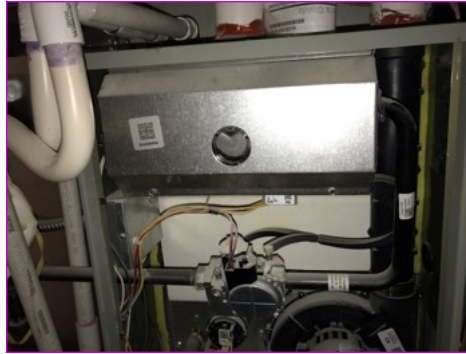
FURNACE Combustion Chamber

- The furnace was a high-efficiency system and had a sealed combustion chamber which would require invasive measures which lie beyond the scope of the General Home Inspection to inspect. The Inspector recommends that, before the expiration of your Inspection Objection Deadline, an evaluation be performed by a qualified heating, ventilation and air-conditioning (HVAC) contractor.

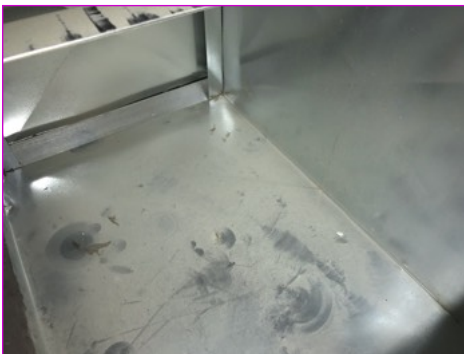
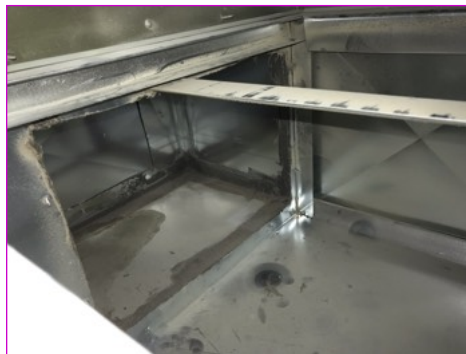
FURNACE Blower

- Dirty furnace blower vanes visible at the time of the inspection should be cleaned to avoid blower damage and increased operation costs. The Inspector recommends service by a qualified heating service technician.

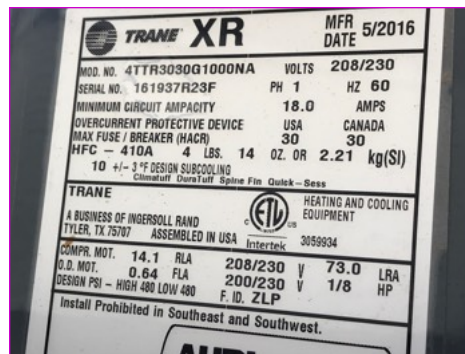
2. Cooling System Data Plate

2016 manufacturing date

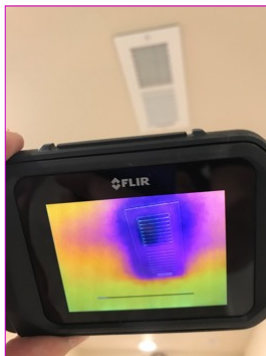
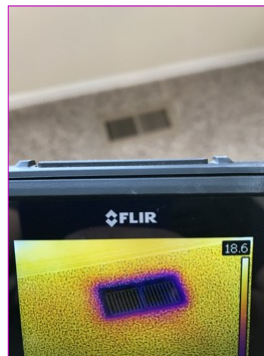
CENTRAL AIR CONDITIONER System Response

- At the time of the inspection, the system responded to the call for cool air.

Cool air

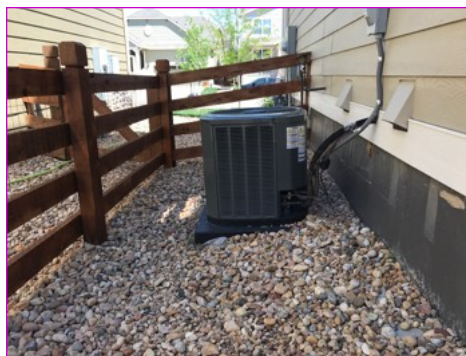
CENTRAL AIR CONDITIONER Compressor Unit

- The pad supporting the air-conditioner compressor housing appeared to be in satisfactory condition at the time of the inspection.

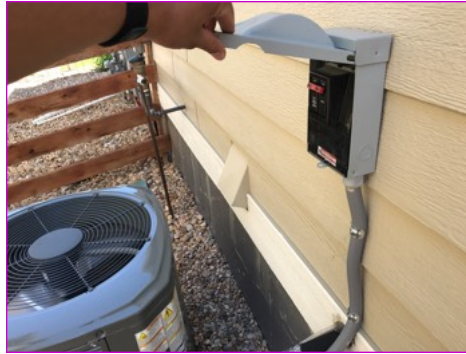
CENTRAL AIR CONDITIONER AC Electrical Disconnect

- Although it was not operated, the electrical disconnect for the condensing unit appeared to be properly located and installed at the time of the inspection. It was not operated.

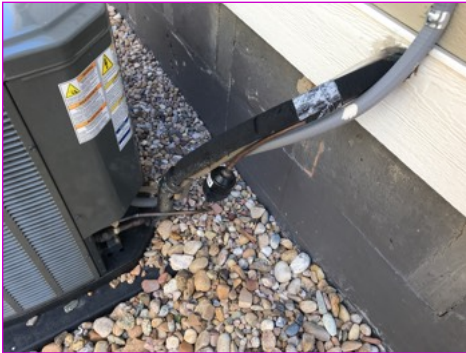
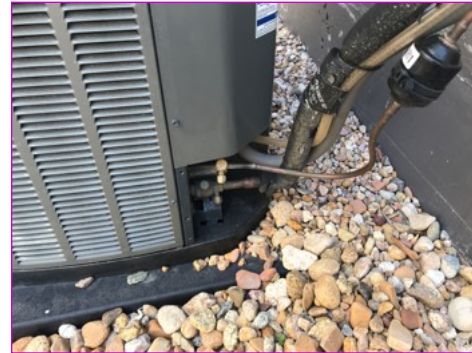
CENTRAL AIR CONDITIONER AC Refrigerant Lines

- At the time of the inspection, the Inspector observed no deficiencies in the condition of the visible air-conditioner refrigerant lines.

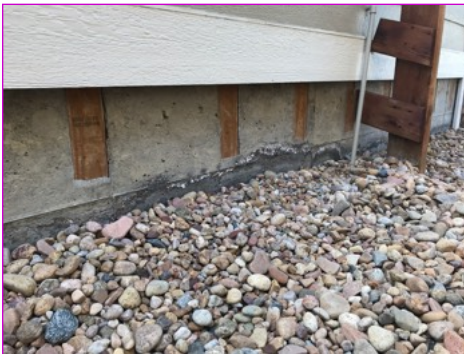
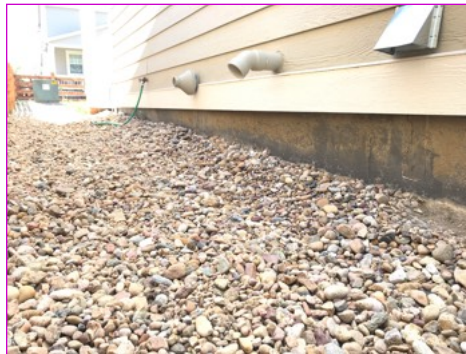
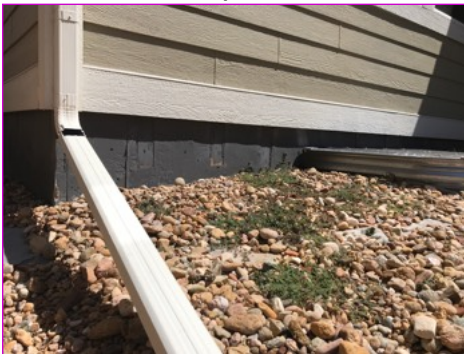
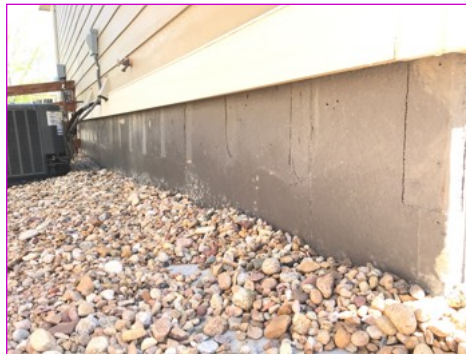
- The visible portions of the foundations walls consisted of poured concrete.
- A portion of the foundation walls were hidden behind thermal insulation. In these areas, inspection of the foundation walls was limited to representative areas only.
- At the time of the inspection, the Inspector observed no deficiencies in the condition of the visible portions of the poured concrete foundation walls.
- Suggest sealing or water proofing exposed frame members left in foundation wall to prevent exposure to moisture and pests.

Suggest sealing or water proofing exposed frame members left in foundation wall to prevent exposure to moisture and pests.

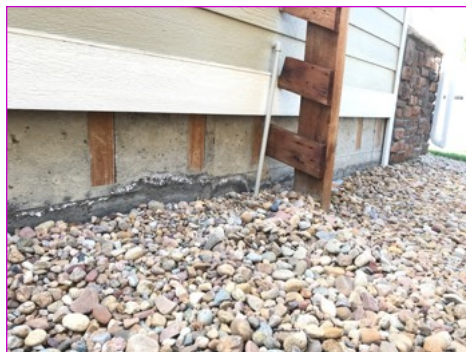
3. Concrete Foundation Walls (cont.)

- Portions of the concrete foundation wall surfaces exposed to weather exhibited minor deterioration and efflorescence.

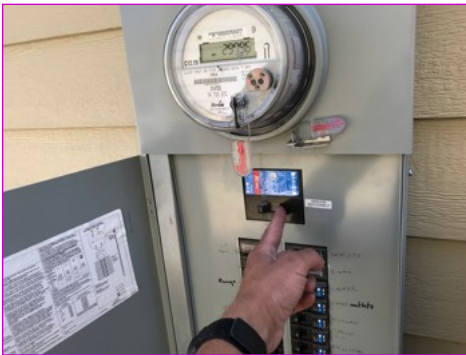
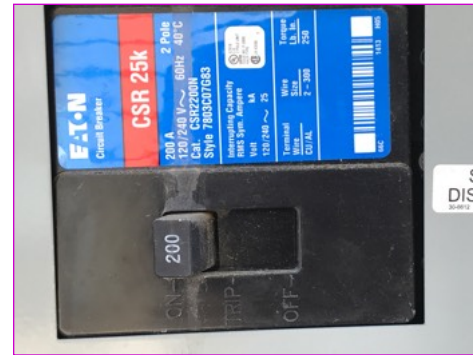
SERVICE PANEL Main Disconnect

- At the time of the inspection, the Inspector observed no deficiencies in the condition of the electrical service disconnect. It was inspected visually but was not operated.

200 Amp Service

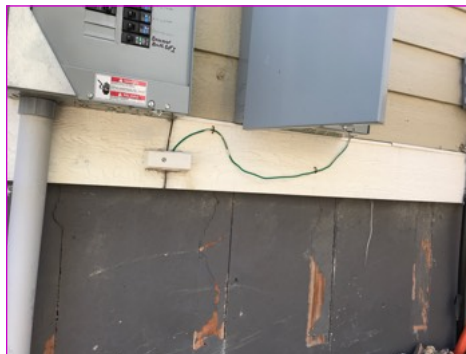
9. Service Grounding

- The service was grounded to steel re-bar left protruding from the foundation for this purpose. This type of ground is called a "ufer" (YOO-fer) ground. This type of grounding electrode has length and continuity requirements which could not be confirmed at the time of the inspection due to the fact that the grounding electrode was encased in concrete. Evaluation of the effectiveness of the service ground would require the services of a qualified electrical contractor using special instruments.

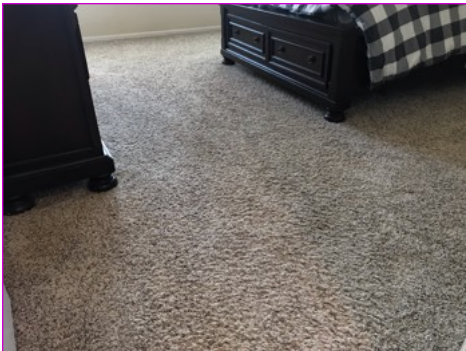
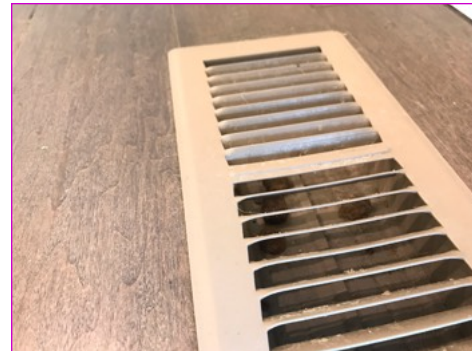
- The inspector suggests carpet and vent/duct cleaning by a reputable professional due to cat odor and hair in Ducts.

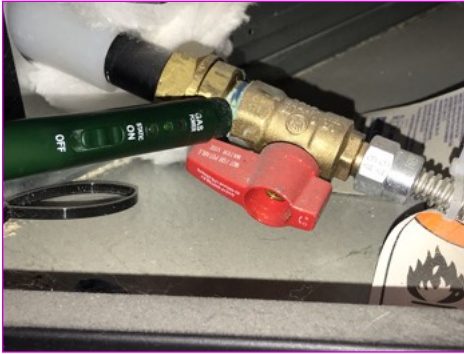
• At the time of the inspection, the Inspector observed no deficiencies in the condition of the gas-fueled fireplace in the . Full inspection of gas-burning fireplaces lies beyond the scope of the General Home Inspection. For a full inspection to more accurately determine the condition of the fireplace and to ensure that safe conditions exist, the Inspector recommends that you have the fireplace inspected by an inspector certified by the Chimney Safety Institute of America (CSIA). Find a CSIA-certified inspector near you at <http://www.csia.org/search>

Gas valve for fireplace

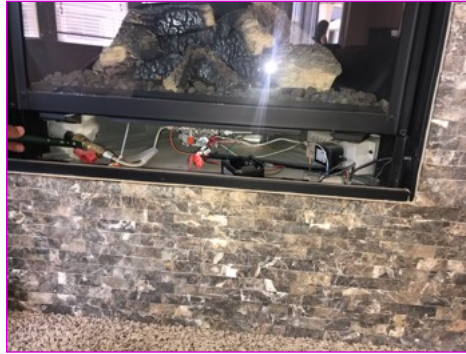
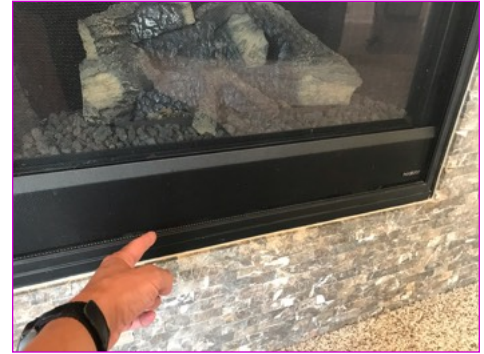
Controls and gas valve

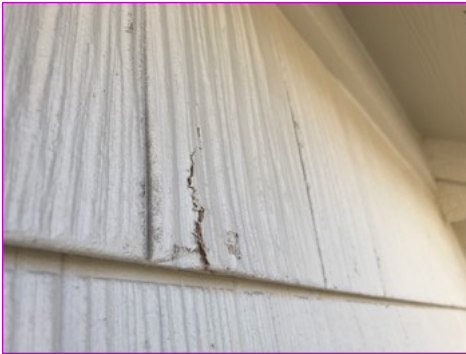
Seal and minor touch-up needed at the exterior.

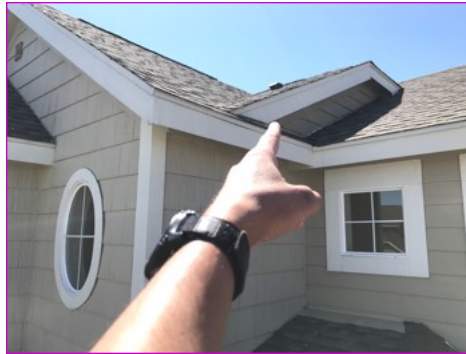
Inspector suggests sealing with sealant or foam at the soffits on the upper right side of the roof to prevent pest intrusion to the attic space. Gap present at flashing.

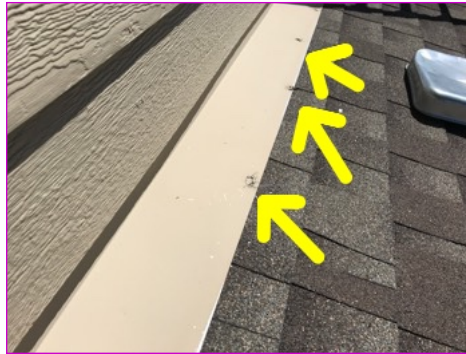
Be sure to maintain the sealant over the exposed nails at the flashing about the rear patio.

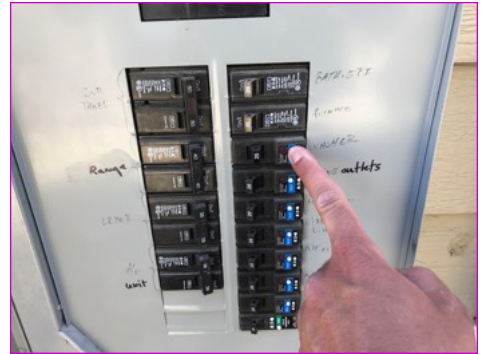
The breaker to the washer did not function properly when tested at the button at the outside service panel. The inspector suggests replacing this a AFCI/GFCI breaker by a professional electrical contractor for safety.

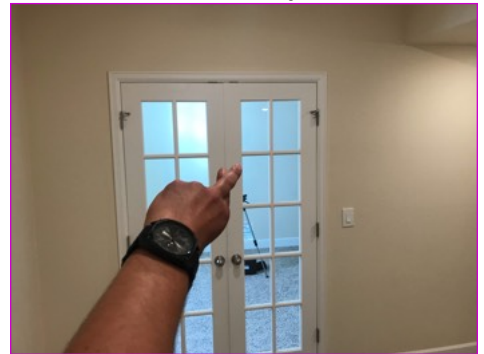
French door in the basement is tight and rubs together. Suggest correction/shaving or sanding the door.
